Contract #: 04-0120F4Cty: SF/ALA Rte: 80 PM: 13.2/13.9File #: 69.28**WELDING INSPECTION REPORT****Resident Engineer:**Pursell, Gary**Address:** 333 Burma Road**City:** Oakland, CA 94607**Report No:** WIR-013181**Date Inspected:** 07-Apr-2010**Project Name:** SAS Superstructure**OSM Arrival Time:** 700**Prime Contractor:** American Bridge/Fluor Enterprises, a JV**OSM Departure Time:** 1190**Contractor:** Zhenhua Port Machinery Company, Ltd (ZPMC), Changxing Island **Location:** Shanghai, China**CWI Name:** Li Yang**CWI Present:** Yes No**Inspected CWI report:** Yes No N/A**Rod Oven in Use:** Yes No N/A**Electrode to specification:** Yes No N/A**Weld Procedures Followed:** Yes No N/A**Qualified Welders:** Yes No N/A**Verified Joint Fit-up:** Yes No N/A**Approved Drawings:** Yes No N/A**Approved WPS:** Yes No N/A**Delayed / Cancelled:** Yes No N/A**Bridge No:** 34-0006**Component:** OBG**Summary of Items Observed:**

On this day CALTRANS OSM Quality Assurance Inspector (QA) Joe Alaniz was present during the times noted above for observations relative to the fabrication of the SAS Superstructure being performed by Zhenhua Port Machinery Company (ZPMC) at Changxing Island in Shanghai, C

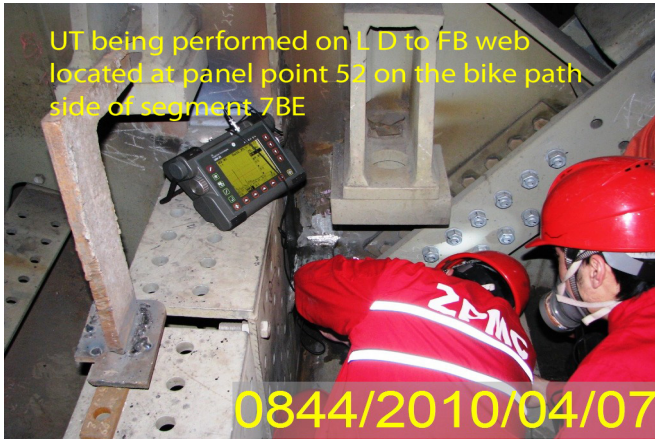
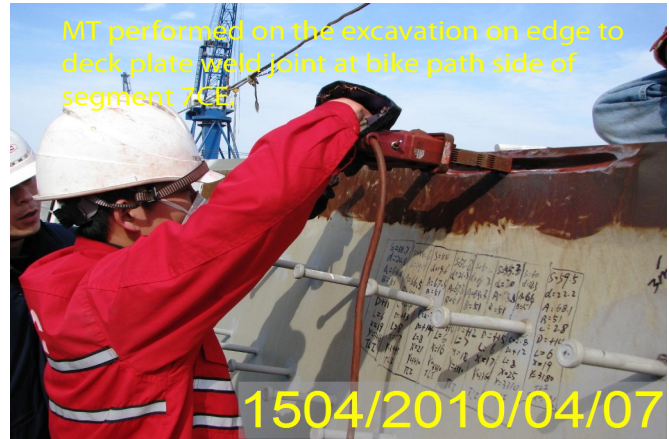
This QA Inspector observed ZPMC Ultra Sonic Testing (UT) Technician performed UT on various locations in the trial assembly yard. Locations are as followed:

1. Longitudinal diaphragm to floor beam web located at panel point 52 on the bike path side of segment.
